Quantitative Three-Dimensional Analysis of Structural Damage in Penetrated Magnesium via XCT

ARL-TR-5359

September 2010

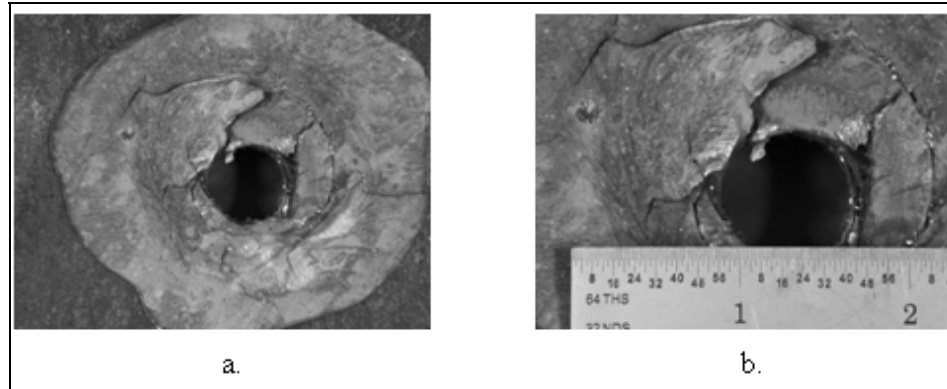
Figure 1. Photographs of rear (exit) side damage in the Mg plate.

hole that was pushed out from the rear of the specimen. The second photograph (figure 1b) includes a ruler to indicate the size of the hole near the rear face, which is ~25 mm across. Digital radiographs (DRs) of the specimen were taken through its thickness and width (edge on) using the 420-keV x-ray tube and linear detector array (LDA) setup in centered rotate-only (RO) mode. The x-ray technique (parameters) of the DRs of the specimen were (400 keV, 2.0 mA) and geometries of source-to-object distance (SOD) = 750.00 mm and source-to-image distance (SID) = 940.00 mm. Figure 2 shows two through thickness DRs (a and b) and one edge on DR (c) of the specimen. The first two DRs have been processed or “windowed” differently to accentuate one or some features over others. In the first, the penetration hole itself is emphasized and shows a darker area to the lower left of the hole due to missing material in the front (impact) side of the specimen. In the second image, the overall damage and the perimeter of the pushed out region of material in the exit side of the specimen is emphasized. It shows the main hole and the region with impact side missing material as all black. In the edge on (side) image of the specimen with the impact side on the left, the main hole is evident, as well as severe damage in the middle and rear regions of the specimen and the missing material that was pushed out of the exit side. This is also the first image that shows some of the nature of the approximately parallel lateral, or “petal-like,” damage mode in the middle and towards the rear of the specimen, which is significantly more visible in the cross-sectional XCT images.

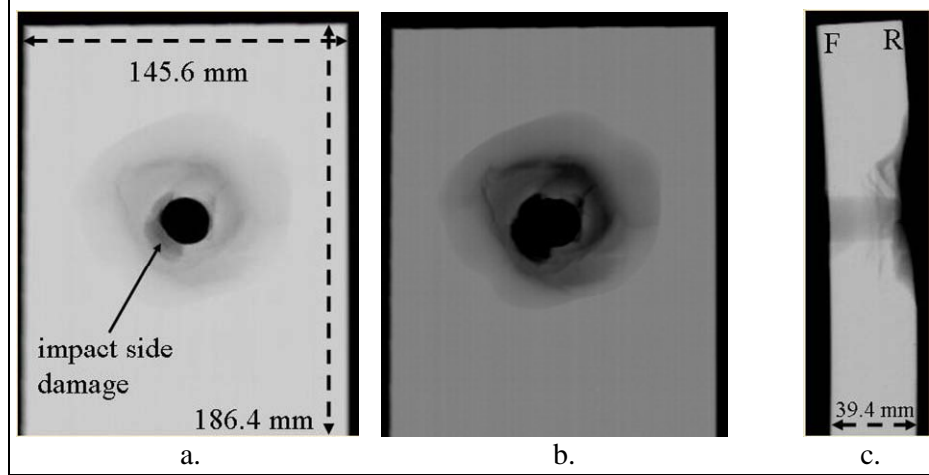
Figure 2. Through thickness (a and b) and edge on (c) digital radiographs of the Mg plate.

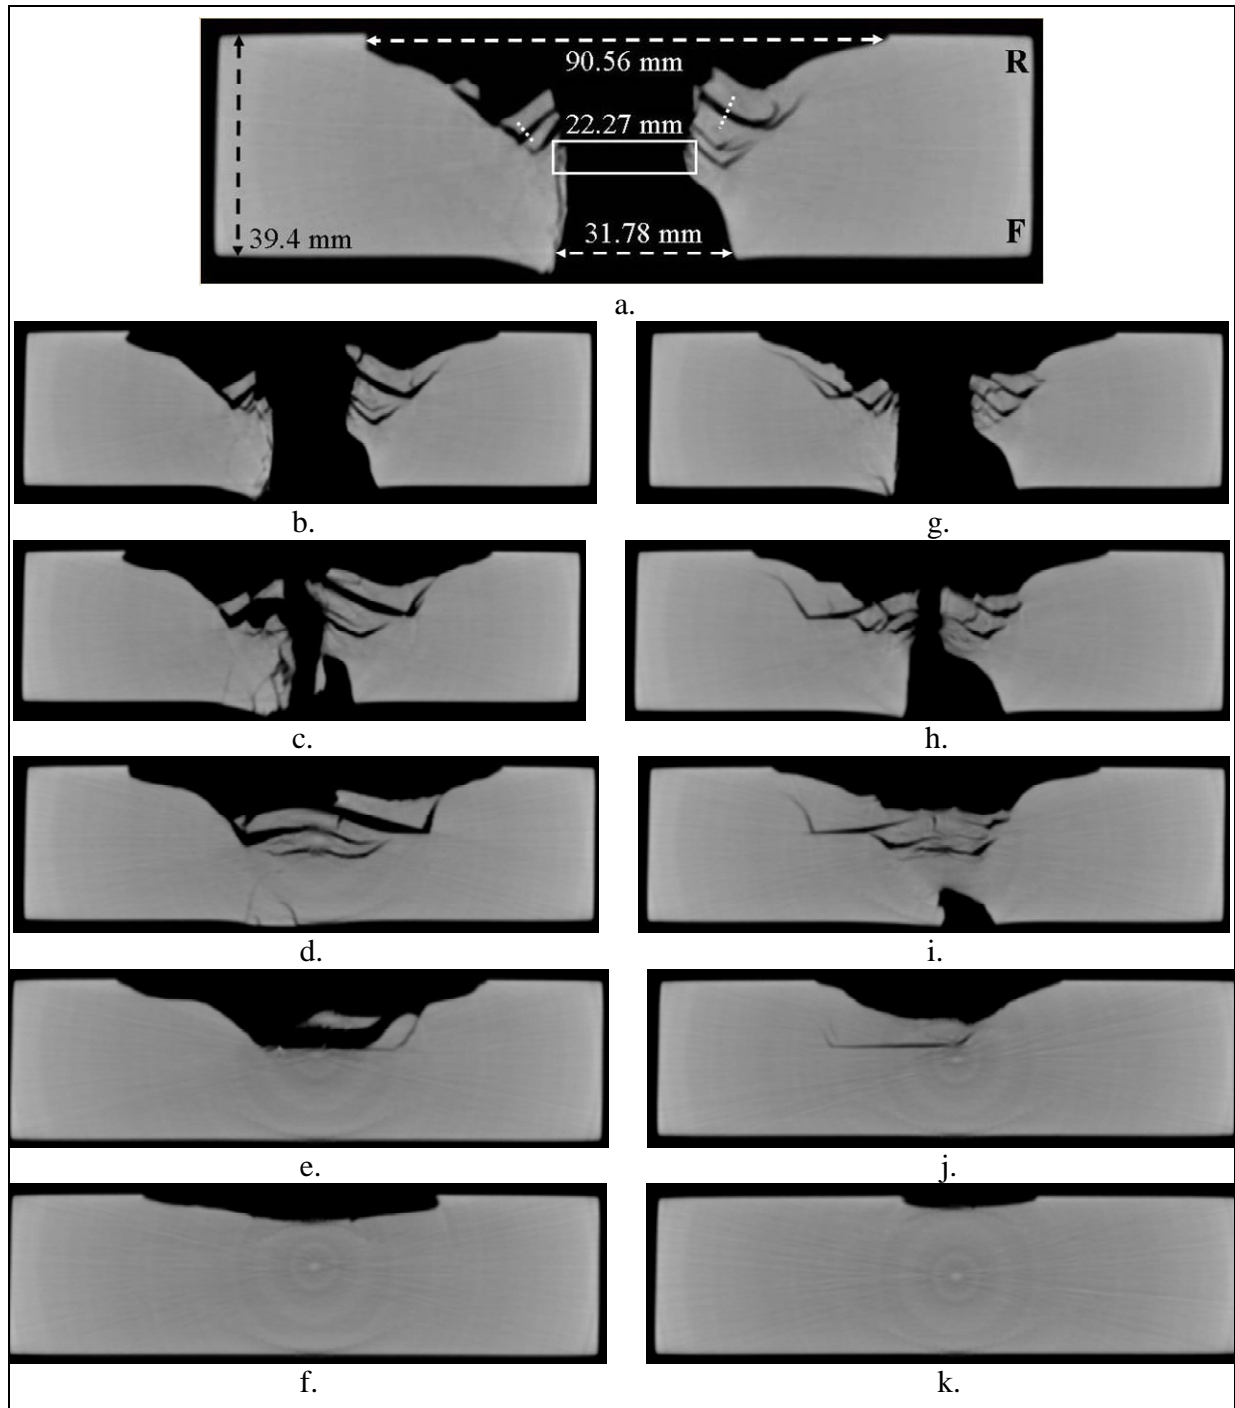
Figure 3 shows a series of CT scans (images) of the specimen, with the first at the vertical position of 116.30 mm (figure 3a), which was within 0.20 mm of the position of the center line of the main penetration hole. The scans in figures 3b–f were taken at vertical positions of 121.25, 126.20, 131.15, 141.05, and 150.95 mm, respectively. The scans in figures 3g–k were

taken at positions of 111.35, 106.40, 101.45, 91.55, and 81.65 mm, respectively. The impact and exit sides of the specimen are at the bottom and top of the images, respectively, and the thickness is 39.4 mm. The missing material towards the front of the specimen adjacent to the main hole is indicated by the shoulder on the right hand side of the cavity wall in figure 3a. A series of approximately parallel lateral, or “petal-like,” cracks on both sides of the penetration cavity are evident. The cracks have the appearance of starting in one direction from the sides of the cavity and then turning or bending back from the original direction towards the rear of the specimen. At some depth into the specimen, the lateral damage mode stops and a relatively large amount of material is pushed out of the exit side. The width of the cavity at the very front and rear of the specimen is 31.78 and 90.56 mm, respectively. The narrowest width is 22.27 mm, which is in the middle thickness region. The width of the uppermost cracks towards the rear of the specimen on both the left and right hand side of the penetration cavity is about 1.4 mm. The scans in figures 3b–f are 5.15, 10.10, 15.05, 24.95, and 34.85 mm above the main hole center line, respectively. The parallel lateral cracking damage mode is evident in figures 3b–e, to a lesser extent. These images do not show a high level of cracking oriented approximately in a through thickness direction. The scans in figures 3g–k are 4.75, 9.70, 14.65, 24.55, and 34.45 mm below the center line, respectively. The same lateral damage mode is evident in figures 3g–j, with a similar relative lack of through thickness cracking.

Figure 3. Cross-sectional CT scans (images) of damage in the Mg plate: (a) vertical position of 116.30 mm, (b) 121.25 mm, (c) 126.20 mm, (d) 131.15 mm, (e) 141.05 mm, (f) 150.95 mm, (g) 111.35 mm, (h) 106.40 mm, (i) 101.45 mm, (j) 91.55 mm, and (k) 81.65 mm.

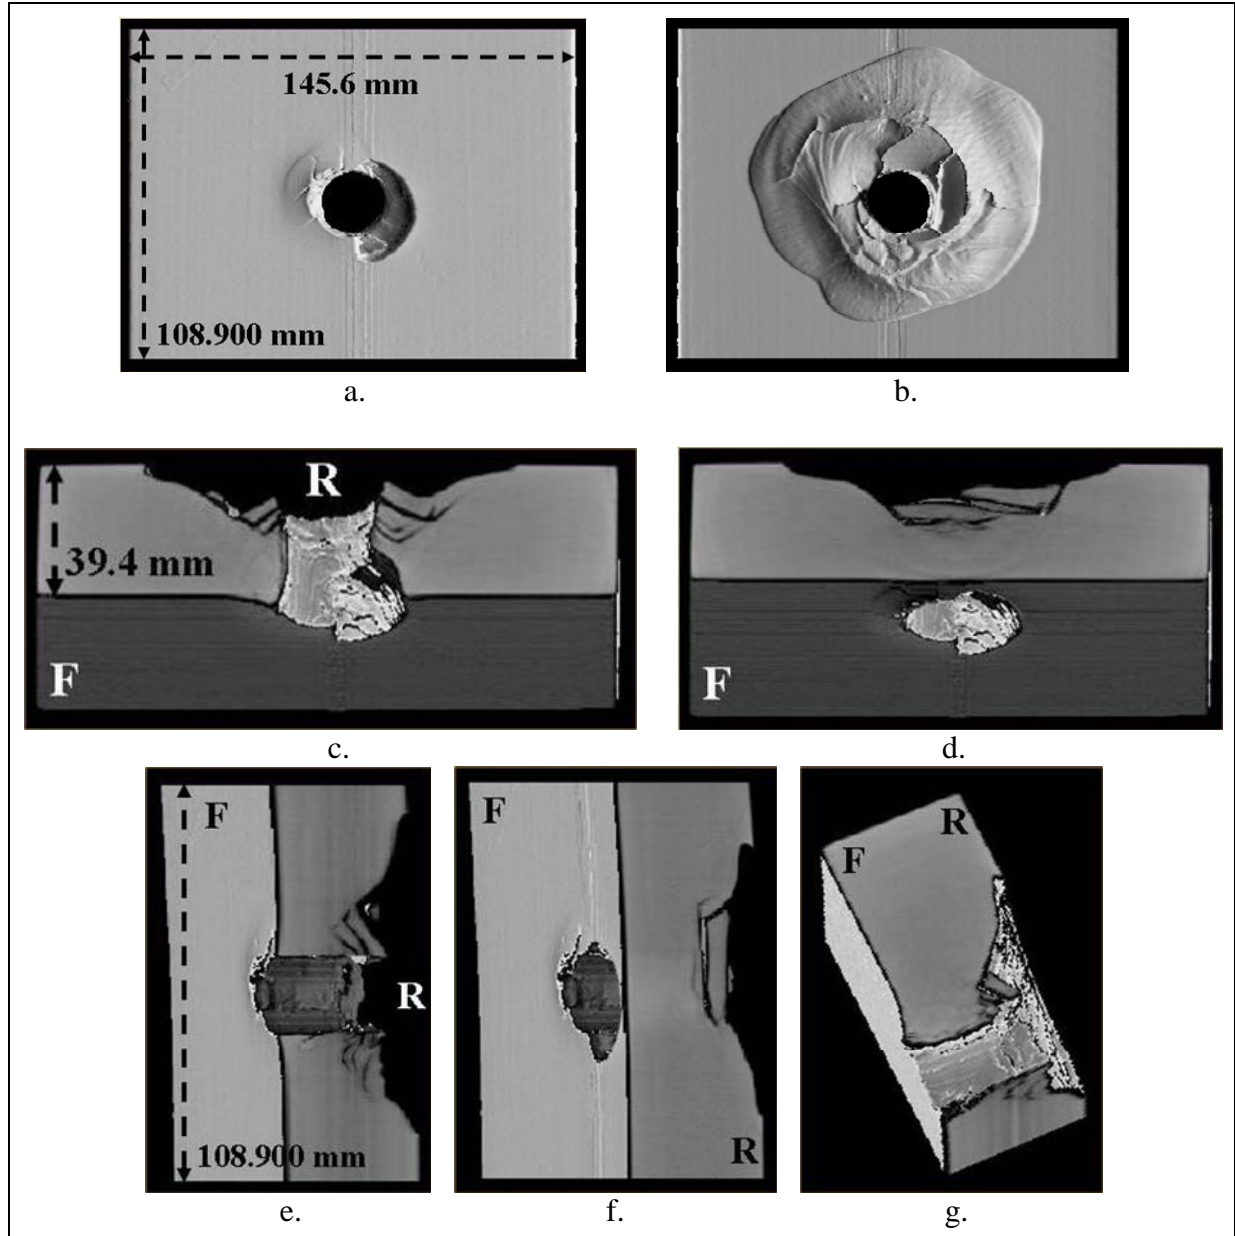
The excellent dimensional accuracy and the digital nature of XCT images allow the accurate volume reconstruction of multiple adjacent or overlapping slices. A virtual 3-D solid image is created by electronically stacking the XCT images, which have thickness over their cross-sections (i.e., voxels), one on top of the other from the bottom to the top of the specimen, or scanned height, to generate its virtual volume. Figure 4 shows a set of seven 3-D solid images of the scanned volume with sections virtually removed in figures 4c–g. The method of virtual sectioning, which is essentially only showing a portion of each scan, allows viewing of generated surfaces anywhere in the scanned volume in 3-D space. Figures 4a and b show views of the impact and exit side, respectively, of the entire scanned volume. The very light vertical banding down the middle of the images (top and bottom) is an image artifact from the reconstruction. It is not an indication of a real physical feature in the specimen. The relative shading of lighter and darker gray in the damaged areas is produced by virtual lighting. Physical texture in the surface of the damage in the rear of the specimen is visible in figure 4b. In figure 4c, the impact side of the specimen is at the bottom of the image and the sectioned surface is approximately halfway between the top and the bottom of the main penetration hole. In figure 4d, the sectioned surface is just above the top of the main penetration hole. The relatively lighter surface of the penetration cavity in figures 4c and d is due to the angle of the virtual lighting. In figure 4e, the impact side of the specimen is on the left side of the image and the sectioned surface is approximately halfway between the left and right sides of the main hole. In figure 4f, the sectioned surface is just to the right of the main penetration hole. In figure 4g, two adjacent sectioned surfaces are shown with the impact side of the specimen on the left side of the image. The main penetration hole has been virtually cut in half both horizontally and vertically. All of the sectioned surfaces in figures 4c, e, and g, which are mutually orthogonal, show the parallel lateral cracking damage mode. This is indicative that this damage mode has a significant degree of symmetry about the trajectory of the penetration. Figures 4d and f also show similar damage in the rear side of the specimen.

Figure 4. A series of virtual 3-D solid volumes of the damage in the Mg plate: (a) front side, (b) rear side, (c) horizontally sectioned through center of penetration hole, (d) horizontally sectioned just above top of penetration hole, (e) vertically sectioned through center of penetration hole, (f) vertically sectioned just to right of penetration hole, and (g) horizontally and vertically sectioned through center of penetration hole.

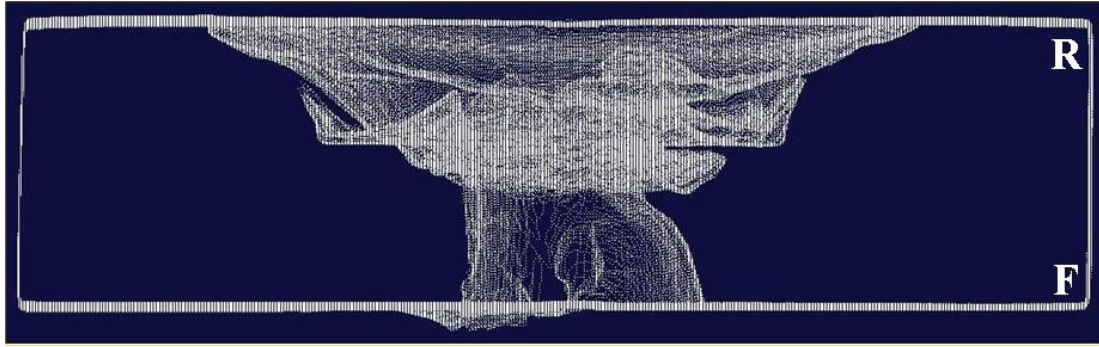
A 3-D point cloud is a set of points in space that define geometrical characteristics (i.e., shape, size, location) of a specimen or scanned volume and features within it. Location of the points is determined by appropriate (image) segmentation of the volume or feature(s) of interest. Figure 5 is a point cloud of the overall damage in the specimen and its outside surfaces from a top-down view (-z direction) with the impact side at the bottom of the image. This view clearly shows that

Figure 5. Top-down view of 3-D damage point cloud along with faces and sides of Mg plate (F indicates front and R indicates rear).

there are three distinct regions of different types of damage. The first region of damage towards the front of the specimen with the shoulder on the right is cylindrical and was produced by the initial penetration of the threat. The diameter of the entrance hole without the shoulder included is 21.04 mm with the center at a height of 116.10 mm. The depth and maximum size (parallel to specimen faces) of this region of damage are about 16 and 33 mm, respectively. The middle region of damage, which has clear delineation from the damage towards the front, exhibits multiple parallel lateral cracks with “upturned” ends that go towards the rear of the specimen. The depth of this region to the ends of the cracks closest to the exit face of the specimen is about 16 mm. The maximum distance between the ends (tips) of the upturned cracks is about 68 mm. The last region of damage is the relatively large amount of material that was pushed out of the rear of the specimen, which overlaps with the middle region of damage. The physical morphology of the middle and rear damage regions is closely intertwined, making it difficult to determine a precise boundary between the two regions. The maximum size (parallel to specimen faces) of the rear region of damage is about 100 mm.

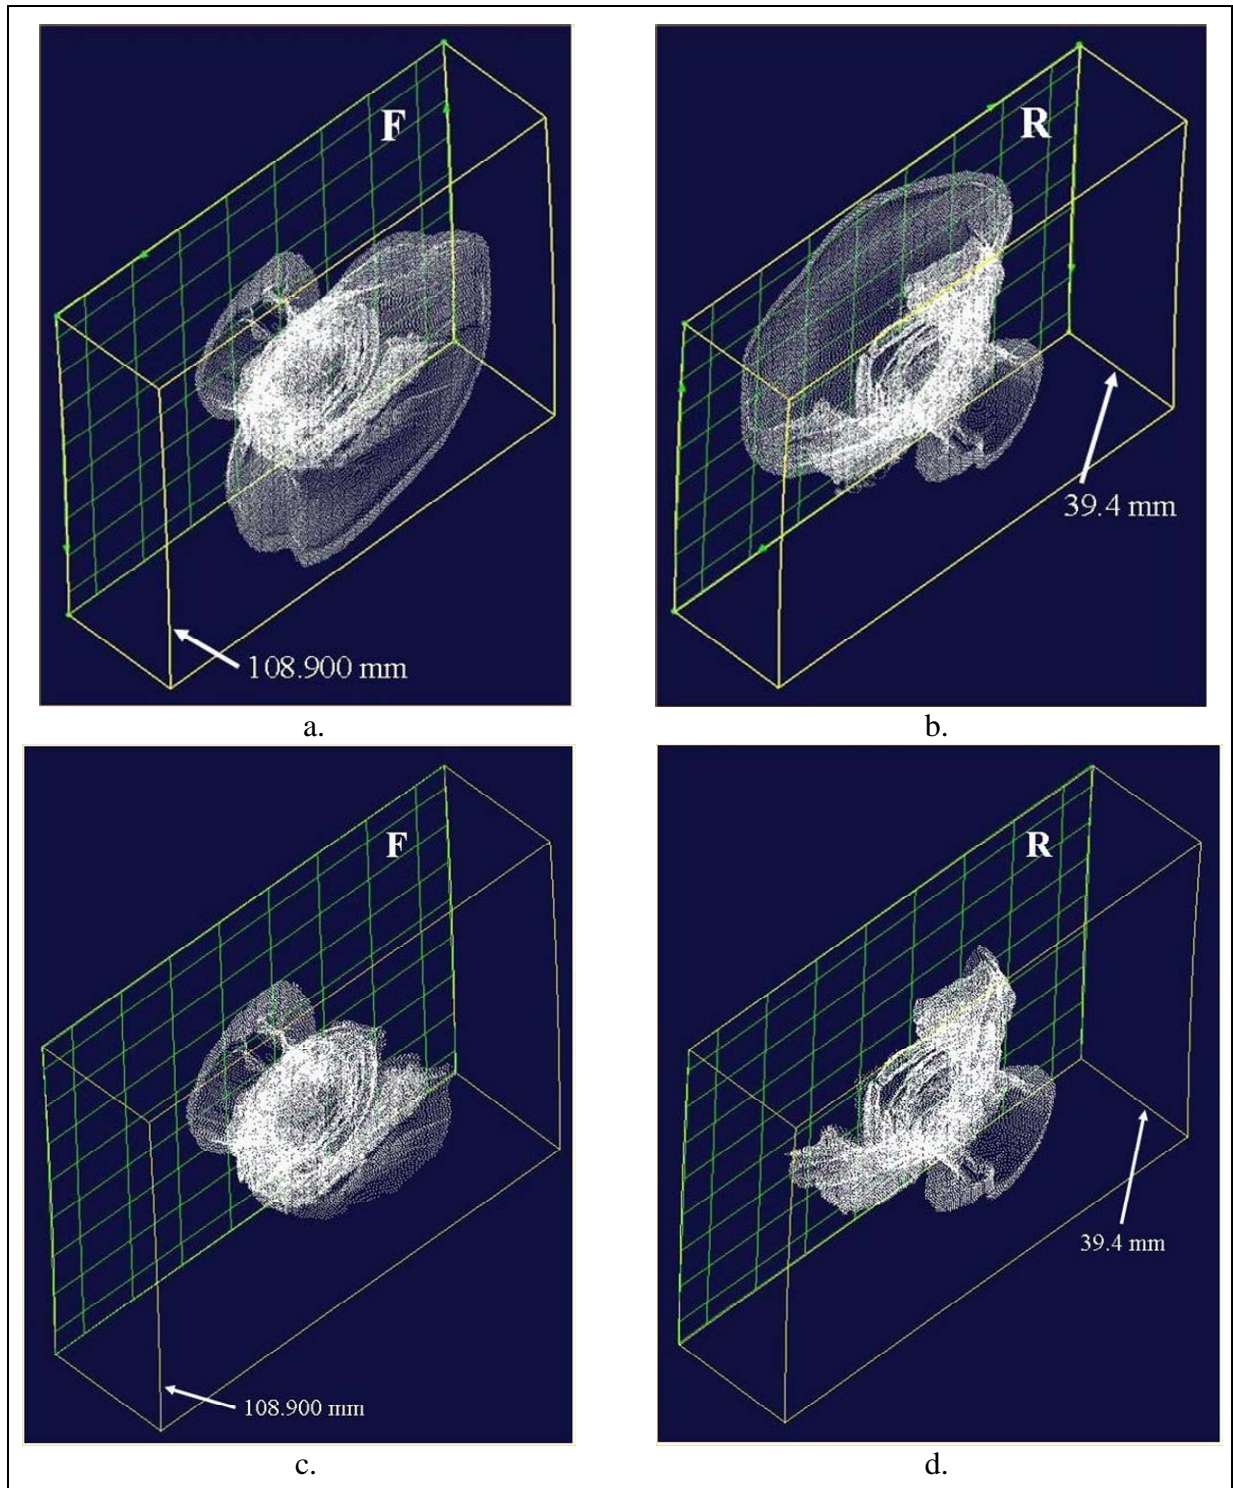
Figures 6a and b are isometric views of the damage point cloud only from exit side and impact side perspectives, respectively, with the boundaries of the scanned volume shown in wireframe mode for reference. The face of the specimen that is away from the view perspective is gridded for ease of interpretation. Figures 6c and d are isometric views of the damage point cloud with the front region of damage removed to provide an unobstructed view of the other damage. Figure 7 is a top down view of the point cloud of the rear region of damage with some overlap into the middle damage. Figure 8 is an approximate top-down view of the point cloud of the middle region of damage with a small portion of the rear damage to better show the orientation of the lateral cracks relative to the shallow cone of material pushed out the rear of the specimen. The point cloud is tilted backward a few degrees from a top down view in order to separate the upturned ends of the cracks from the surrounding damage as much as possible. Figure 9 is a top-down view of the point cloud of the front region of damage, with some points on the front surface of the specimen to the left and right of the entrance hole. The surface around the entrance hole on the left side is physically raised on the specimen.

Figure 6. Isometric views of 3-D damage point cloud only with physical boundaries of scanned volume shown as wireframe and face away from the view gridded (F indicates front and R indicates rear): (a) rear view, (b) front view, (c) rear view with rear damage removed, and (d) front view with rear damage removed.

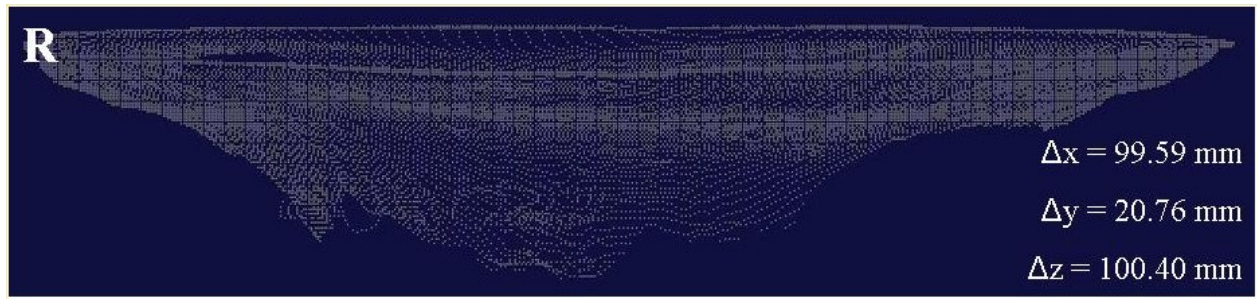
Figure 7. Top-down view of rear section (thickness) of damage point cloud only (R indicates rear side).

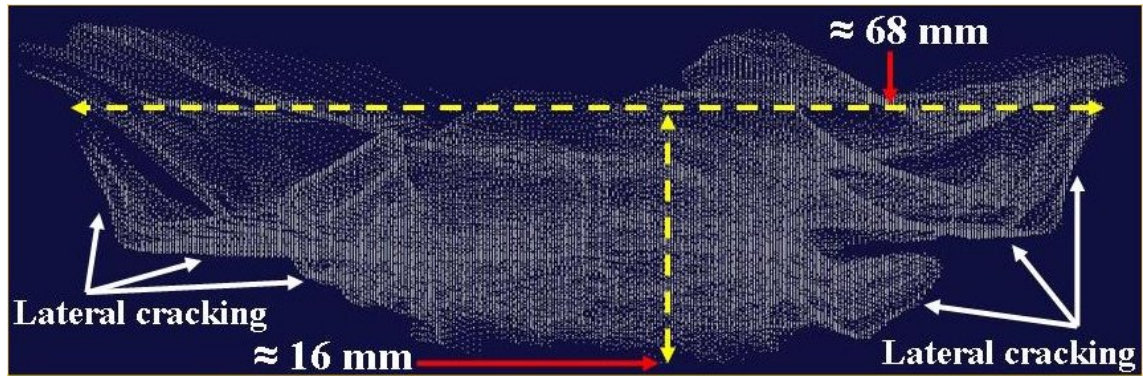
Figure 8. Top-down view of middle section (thickness) of damage point cloud only. The front side of plate is below the bottom of the image.

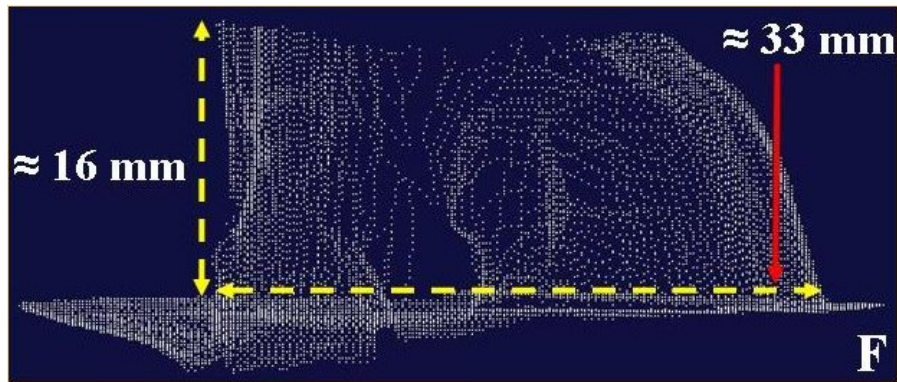
Figure 9. Top-down view of front section (thickness) of damage point cloud only (F indicates front side).

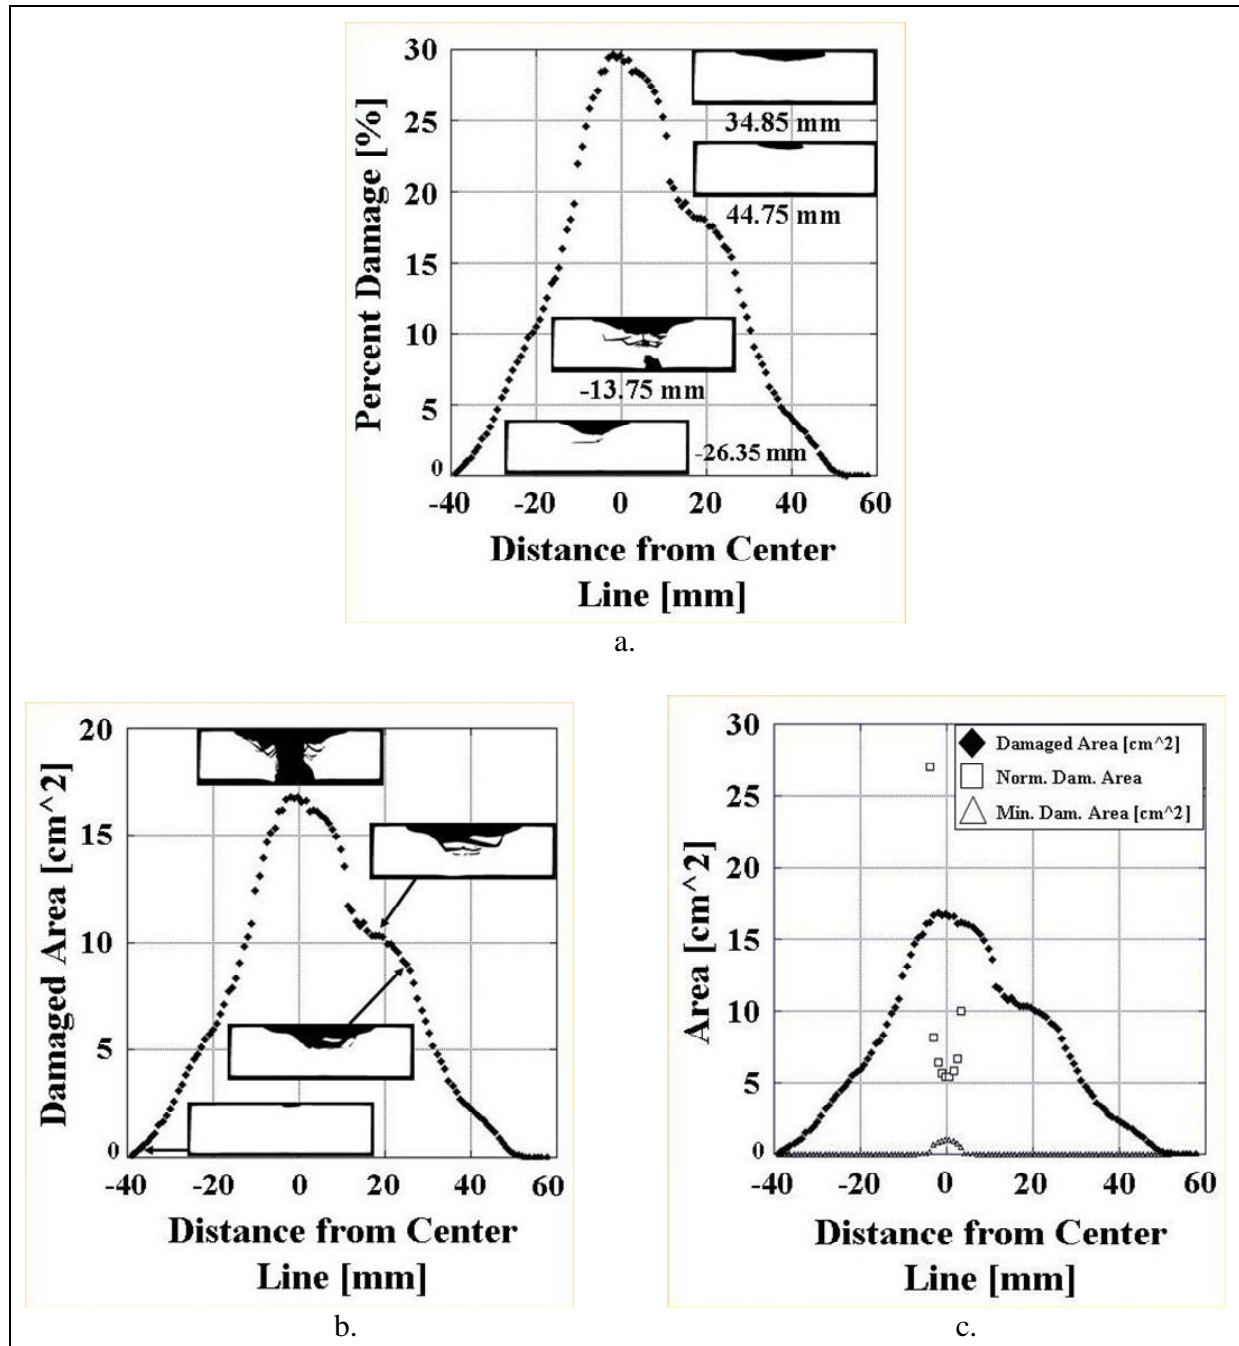
One approach to representing the damage data is to plot the percent damage relative to the cross-sectional area of the specimen against the vertical distance above and below the center line of the penetration cavity. This does show the trend in the overall damage from the bottom to the top of the cavity, as seen in figure 10a. Individual segmented binary XCT scans are overlaid on the plot to show the damage at specific locations. However, in this case the amount of damage is not in terms of an absolute quantity since the cross-sectional area depends in part on the width of the specimen as cut from the larger test plate. A more informative representation of the data is shown in figure 10b in which the pixel area, 0.036 mm^2 from an areal pixel density of 2758 cm^{-2} , was used to convert number of pixels in a damaged state to total damaged area and plot it versus the distance from the center line. Again, individual segmented binary XCT scans are overlaid on the plot to show the damage at specific locations. The most interesting feature of this plot is the shoulder on the right about 20 mm above the center line. The two binary images shown in this vicinity appear to indicate that less material remained on the left side of the penetration cavity. Figure 10c shows the damaged area plot as well as minimum possible damage from complete penetration and normalized damaged area plots.

The minimum damage plot (triangles) is based on the amount of damage that would be present due to a uniform penetration hole through the thickness of the specimen with a diameter equal to the diameter of the base of the threat. Therefore, the minimum damage is 0 if the distance above or below the center line is one threat radius or greater. The normalized damaged area plot (squares) is simply the damaged area plot (black diamonds) divided by the minimum damage plot. It shows that the damaged area produced by the penetration at the center line is approximately $5\times$ greater than the damage that would exist from a minimum complete penetration hole.

Figure 10. Plots of damage vs. vertical distance from center line of penetration cavity (positive indicates above and negative indicates below center line): (a) percent damaged area perpendicular to faces, (b) damaged area perpendicular to faces, and (c) damaged area, minimum damage area, and normalized damaged area on same plot for comparison.

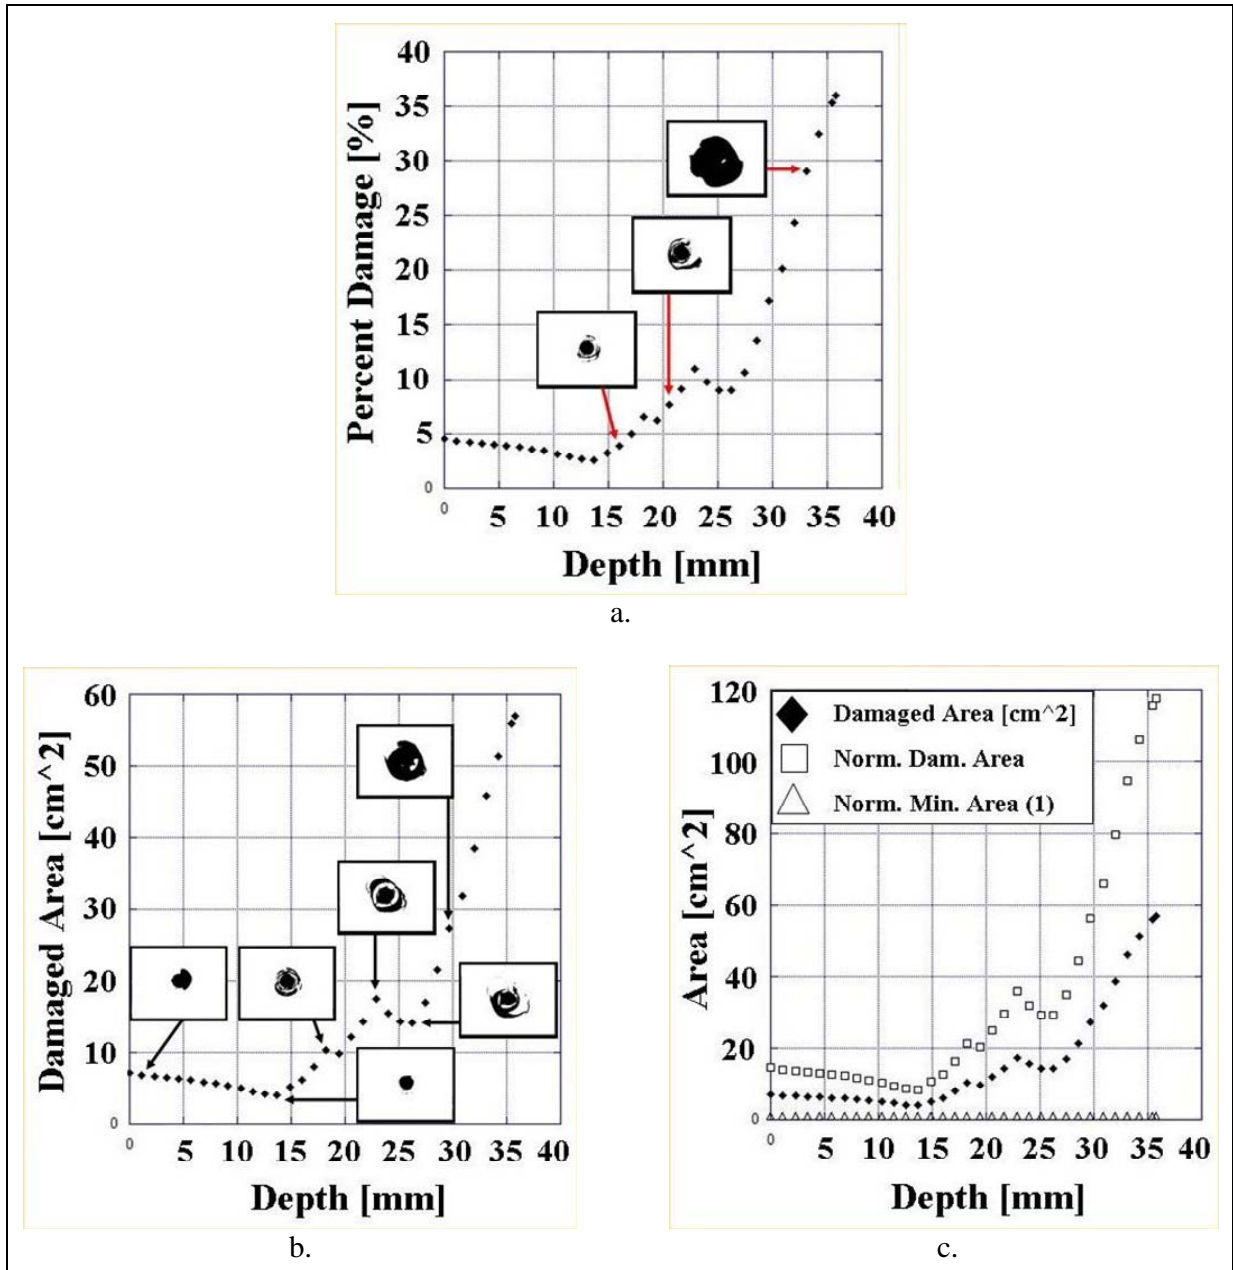
Figure 11a is a plot of the percent damaged area parallel to the faces of the specimen versus depth from its impact face. Individual segmented binary vertical slices are overlaid on the plot to show the damage at specific locations. Figure 11b is a plot of the damaged area parallel to the faces of the specimen versus depth from its impact face. Again, individual segmented binary vertical slices are overlaid on the plot to show the damage at specific locations. The plot has two local maxima and three local minima. This behavior of local peaks and valleys is due to the parallel lateral cracking damage mode in the middle of the specimen. The local spatial periodicity of the minima-to-minima (two) and maxima-to-maxima (one) segments of the damage is about 5 mm. The plot also shows that the area of the penetration hole necks down to a minimum at a depth of about 14 mm and a steep rise after a depth of about 26 mm, which is indicative of the large amount of material pushed out the back of the specimen. Figure 11c shows the damaged area plot as well as normalized minimum and normalized damaged area plots. Again, the normalized minimum plot (triangles) is based on the amount of damage that would be present due to a uniform penetration hole through the thickness of the specimen with a diameter equal to the diameter of the base of the threat. In this case, the minimum possible damage area as a function of depth is a constant, so this plot is normalized to one. The normalized damaged area plot (squares) is the damaged area plot (black diamonds) divided by the constant minimum damage area. In this way, the normalized damaged area plot gives a factor difference between the actual damaged area and the minimum possible damage with complete penetration (factor = 1). For example, at a depth of about 14 mm the damaged area is about nine times greater than the minimum possible damage area for a uniform through thickness hole. Similarly, at the two depths of the local maxima, about 18 and 22.5 mm, the damaged area is about 20 and $37\times$ greater than the minimum, respectively. The through-thickness damaged area is at least approximately one order of magnitude or greater than the minimum possible damage area throughout the penetration cavity.

Figure 11. Plots of damage vs. depth (distance from front face): (a) percent damaged area parallel to faces, (b) damaged area parallel to faces, and (c) damaged area, normalized minimum area, and normalized damaged area on same plot for comparison.
